## Housing Health and Safety Rating System (HHSRS)

## Case Studies

Hazard B12  
Lead

Example B12.1  
1920-45  
Semi-detached  
House  
(Non-HMO)

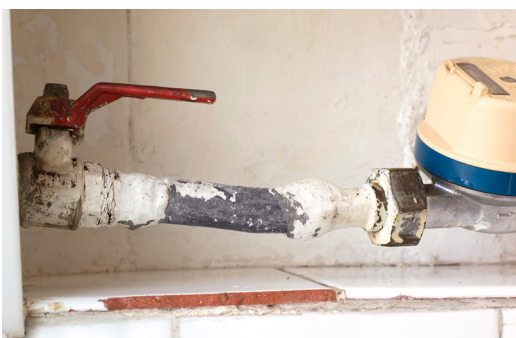
Sections of the original lead pipework between the stop tap, kitchen sink and the electric water heater are still in place. The house is located in South Wales where the water is known to be plumbosolvent because it is soft water, so slightly more acidic (see map below).

2  
Original lead pipe at  
stoptap

The water supply is likely to be contaminated with lead due to the house being in an area of plumbosolvency with soft, acidic water.

Works required to reduce the hazard would include complete removal and replacement of the lead pipework between the stop tap, kitchen sink and electric water heater and replacement with copper or plastic pipes.

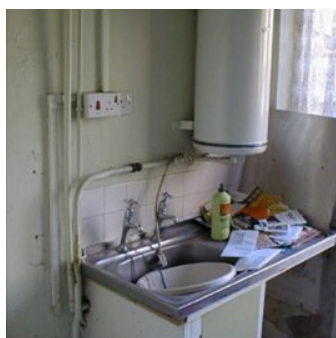
3  
Original lead pipes to  
water heater

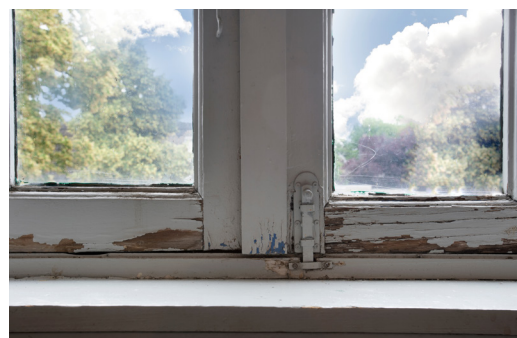
Much of the internal woodwork (windows and doors, window sills, bannisters, etc.) are worn, chipped or peeling, especially in the bedrooms, where condensation on the single-glazed windows is causing the sills to rot and the paint to flake.

4  
Flaking paint on wooden  
sg windows

The likelihood of harm occurring is increased due to the old flaking paintwork, particularly in the bedrooms where the vulnerable group (under 3-year-olds) are likely to spend the majority of their time when considering their sleep is likely to include day time naps as well as overnight and play as well.

Necessary works would also include removal of loose and flaking original paintwork with a liquid paint stripper and appropriate PPE to avoid generating dust. Any rotten or damaged timber should be removed/replaced and redecorated. All original worn-but-sound paintwork should be painted over to seal the surface.
